ASIA TURBOMACHINERY & PUMP SYMPOSIUM
12 - 15 MARCH 2018
SUNTEC SINGAPORE

METALLURGICAL FAILURE ANALYSIS OF STEAM TURBINE, COMPRESSOR, AND HOT GAS EXPANDER COMPONENTS

David Dowson

Service Engineer (Materials & Repairs)
Elliott Group
Jeannette, PA, USA

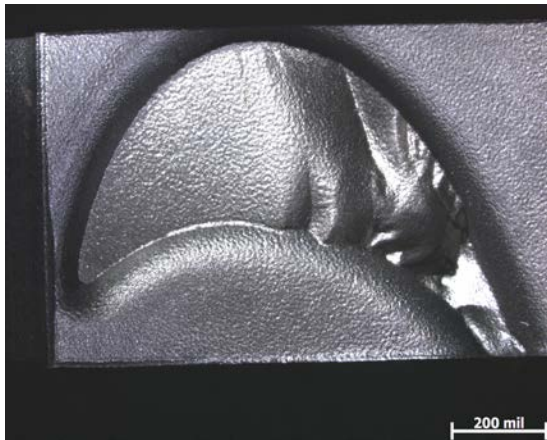
Figure 1. Blast cleaned steam turbine blade which removed all identifiable features

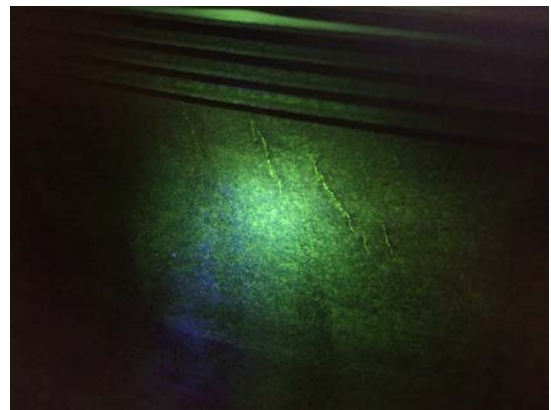
Figure 2. Cracking discovered during magnetic particle inspection of centrifugal compressor impeller

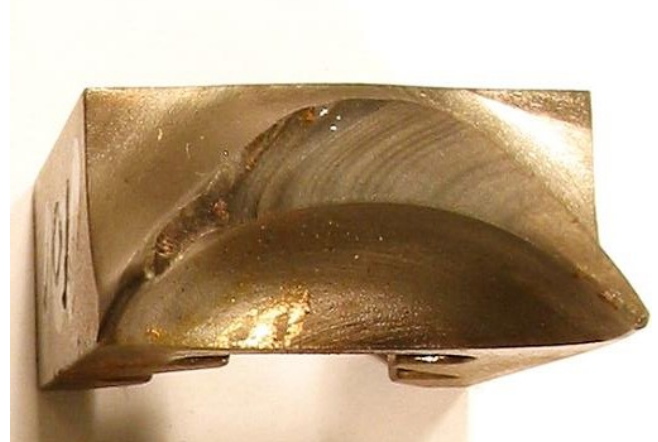
Figure 4. High cycle fatigue failure of steam turbine airfoil

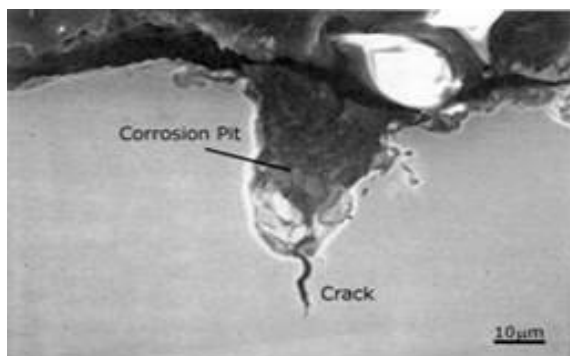
Figure 5. Fatigue crack propagating from corrosion pit

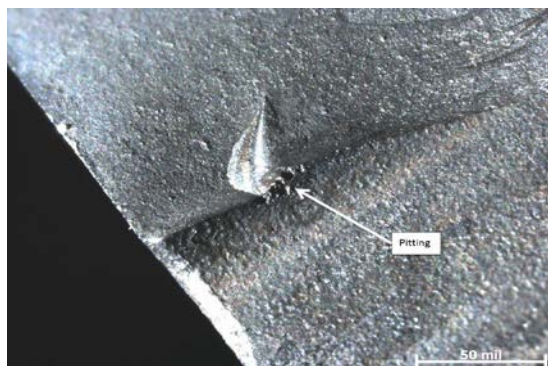
Figure 6. Corrosion pit at initiation of steam turbine blade fatigue failure

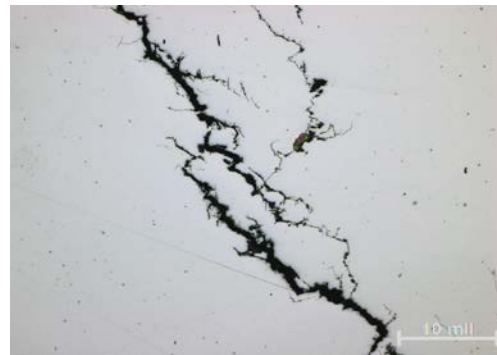
Figure 7. Transgranular SCC of impeller due to chlorides

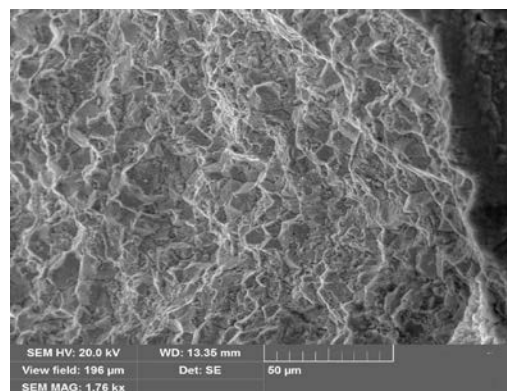
Figure 8. SEM micrograph of intergranular corrosion cracking of steam turbine blade

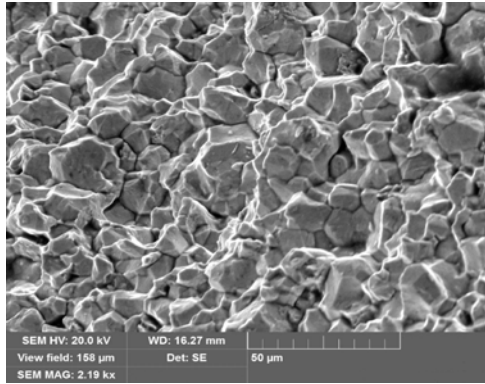
Figure 9. SEM micrograph of intergranular SCC of steam turbine disk

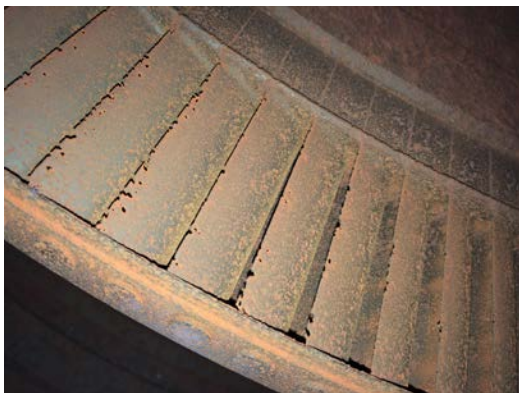
Figure 10. Solid particle erosion of steam turbine blades due to exfoliation of upstream piping/boiler scale

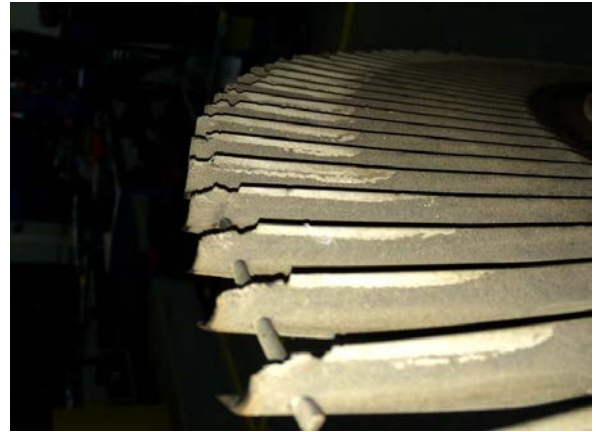
Figure 11. Liquid droplet erosion of last stage blades due to excessive moisture

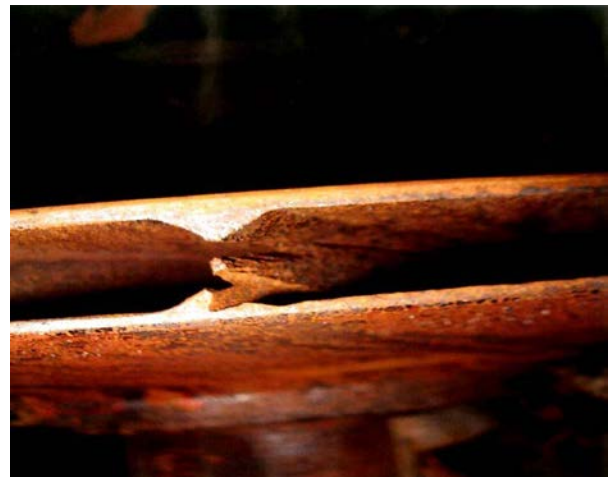
Figure 12. Erosion at discharge of impeller blade

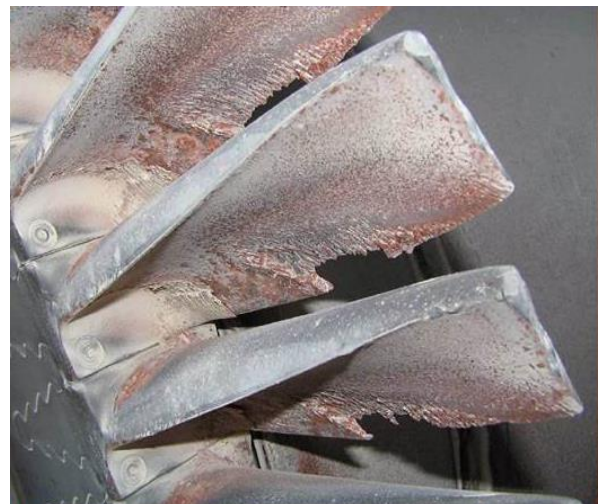
Figure 13. Primary erosion of hot gas expander blades

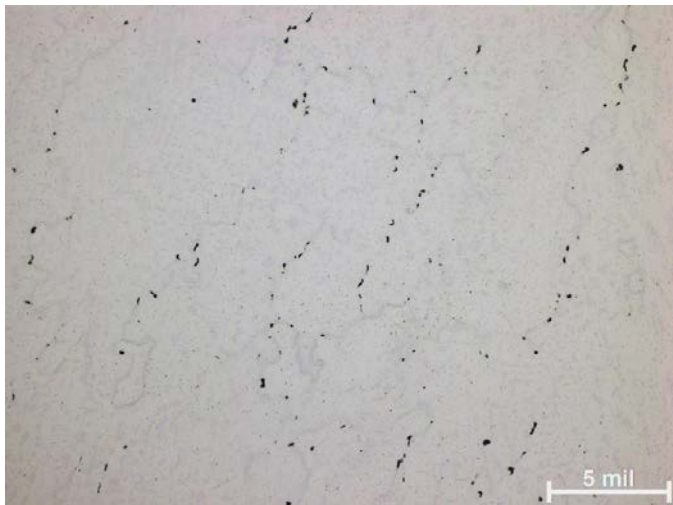
Figure 15. Oriented creep cavities in nose cone strut weld metal of expander inlet casing

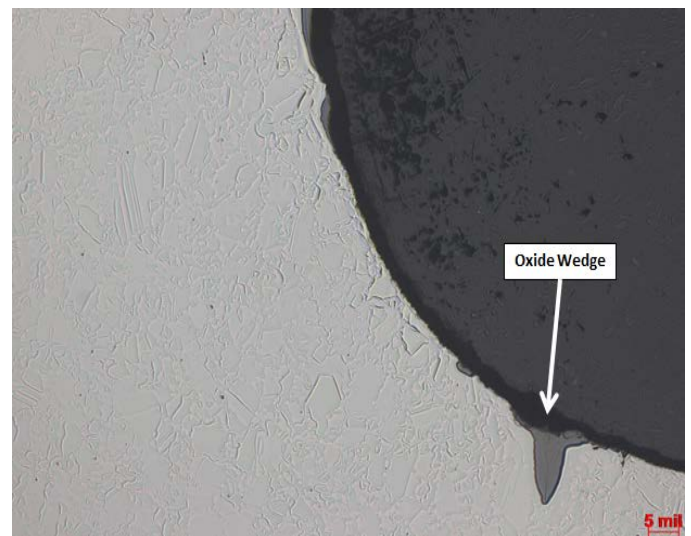
Figure 16. Cross-section of expander blade indicating the presence of an oxide wedge in the root

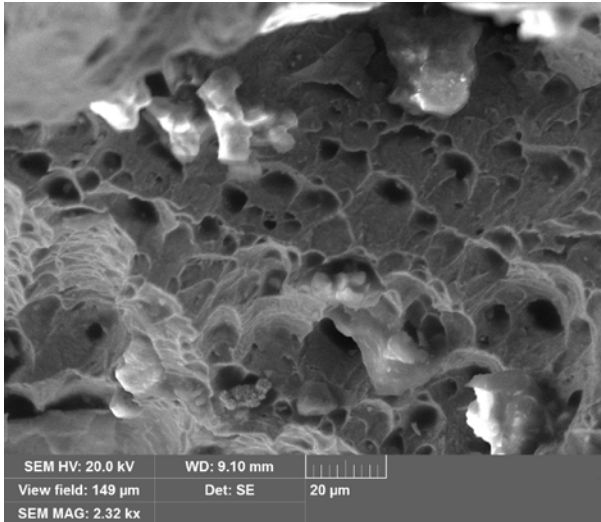
Figure 17. SEM micrograph of steam turbine blade overload failure due to foreign object impact

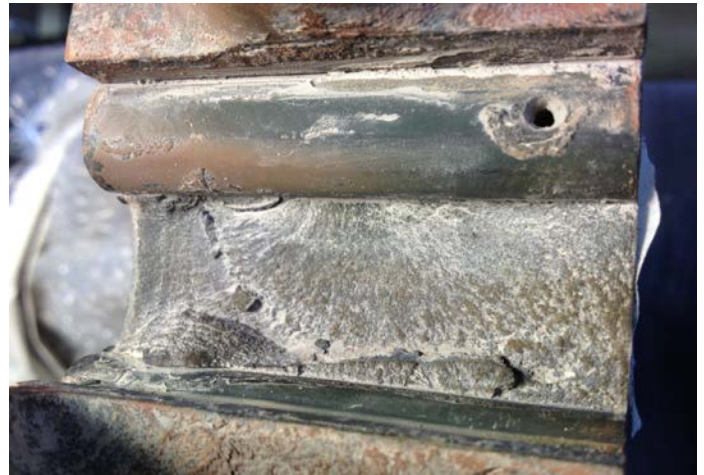
Initial inspection of the failed rotor indicated a single blade failure at the top fir-tree radius in the blade root section (Figure

Figure 18. Failed blade fracture surface prior to disassembly

The failure of the blade was due to corrosion fatigue that initiated at the top fir-tree radius on the pressure side. Initiation occurred due to high temperature corrosion attack and penetration indicating a corrosion assisted process. Sulfur can embrittle Nickel based superalloys as it penetrates down the grain boundaries. The intergranular propagation of the crack along the fracture surface supports a corrosion fatigue damage mechanism. The corrosion media in this case is obviously Sulfur. No material deficiency was found that could have initiated the failure.

Due to the results of this metallurgical analysis, replacement of the disk as well as the blades was recommended. The stresses at the top fir-tree radius of the disk and blade root are very similar. This top fir-tree radius of the disk would have been exposed to the same operating temperature that promoted the formation of oxide wedges in the blade roots. Therefore, it was reasonable to assume that the disk would have experienced the same high temperature corrosion attack that occurred on the blades. Application of current NDE penetrant technologies cannot detect these oxide wedges due to the indications being filled with corrosive oxide deposits.

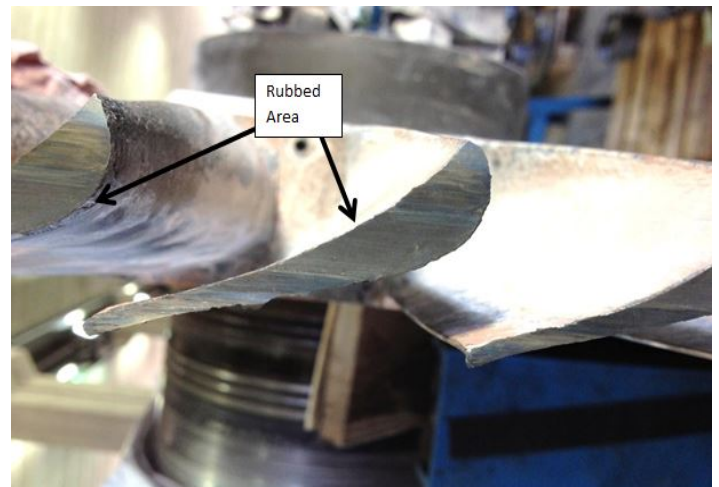
The blades were Non-Destructive Examined (NDE) by fluorescent penetrant and no indications were observed. There was evidence of heavy rubbing on the blade tips of all the blades due to catalyst building up on the shroud (Figure 19).

Figure 19. Blade rubbing on the airfoil tips

The rubbing of the blade tips is a major contributor to the failure and should not be overlooked. The formation of oxide wedges is a function of the temperature, environment and stress. It has been observed during experimental testing and from past failures that an increase in the stress magnitude, whether static or dynamic, in a hot corrosive environment can result in sharp oxide wedges. The application of dynamic stresses compared to static stresses of the same magnitude tends to increase the penetration of the oxide wedges. The rubbing of the blade tips caused fretting at the contact points that

contributed to the breakdown of the protected diffusion coating. The chromized coating applied to the blades should have protected this form of corrosive attack. However, the repeated rubbing of the blades against the catalyst resulted in a dynamic stress being applied in the blade roots. This dynamic stress diminished the effectiveness of the coating exposing the virgin Waspaloy material to hot corrosive attack. Since catalyst buildup on the shroud is a major contributor to the blade tips rubbing, every effort should be made to minimize the rubbing. Application of walnut shells and/or thermal cycling of the hot gas expander can assist in removing catalyst buildup before any future blade rubs occur, with minimal operating interruptions.

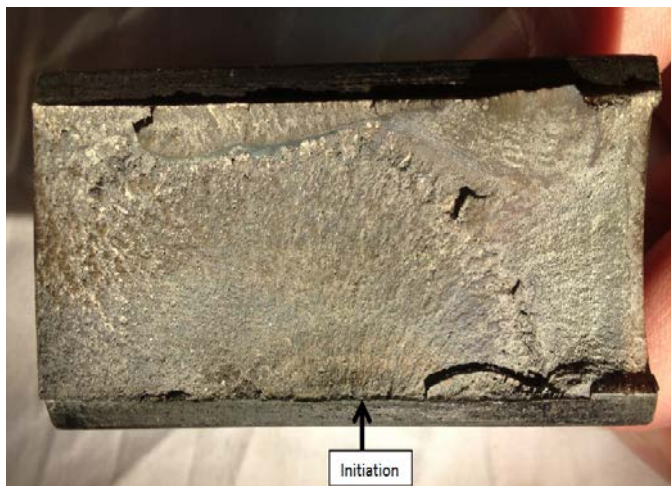
The appearance of the fracture surface of blade #1 is shown in Figure 20. The failure appeared to have initiated midway at the top fir-tree radius on the pressure side of the blade root section. Examination of the fracture surface indicated after initiating the crack propagated through the blade until overload failure at the discharge side of the blade. Located at the point of initiation were flat and smooth areas which are explained in more detail in the Scanning Electron Microscope (SEM) section (Figure 21). These flat and smooth areas were apparent over the crack surface inboard from the top fir tree radius. The fracture surface immediately after the flat and smooth areas had a rough appearance shown at high magnification in Figure 22.

Figure 20. Fracture surface of failed blade

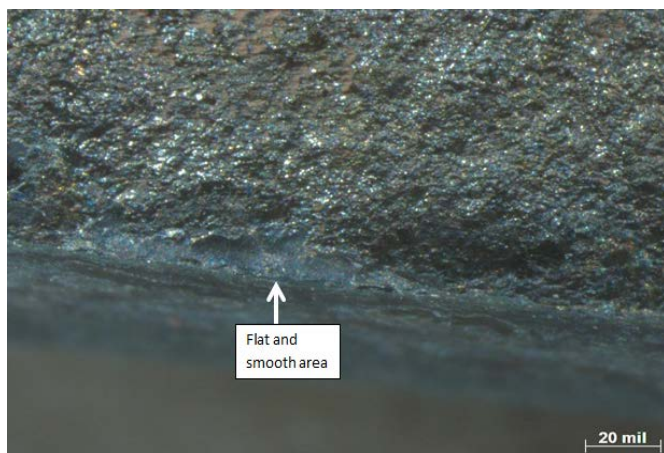
Figure 21. Flat and smooth like areas at the point of initiation inboard from the top fir-tree radius

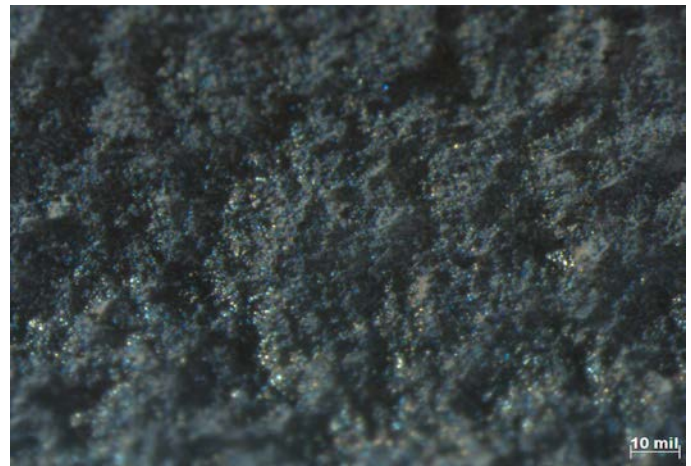
Figure 22. Initiation area at high magnification showing a rough surface appearance

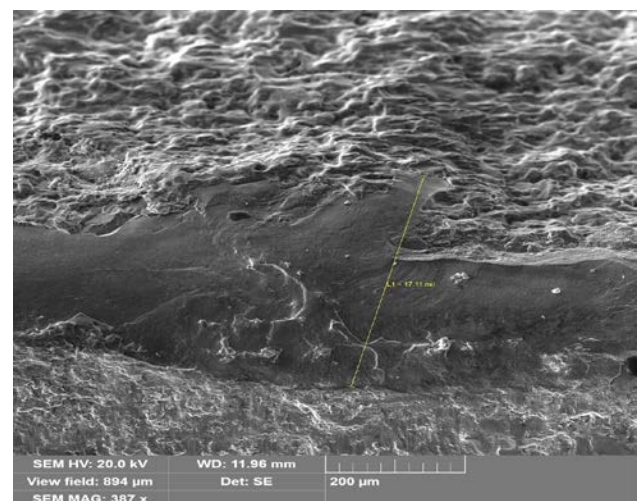
The flat and smooth areas at the initiation which were identified optically showed a brittle appearance when examined under the SEM. Figure 23 showing the area of deepest penetration, which was 17.11 mils. These areas of deep penetration were observed at approximately 1.25 inches from the discharge side. Energy Dispersive Spectroscopy (EDS) analysis of these areas at the initiation showed the major elements present to be Chromium, Oxygen and Sulfur (Figure 24). This indicated the areas were composed of Chromium Oxide and Chromium Sulfide. X-Ray mapping verified that this area consisted of Chromium Oxide and Chromium Sulfide (Figure 25). Note the reduction of Nickel on this area compared to the rest of the fracture surface.

Figure 23. Flat and smooth area examined under SEM

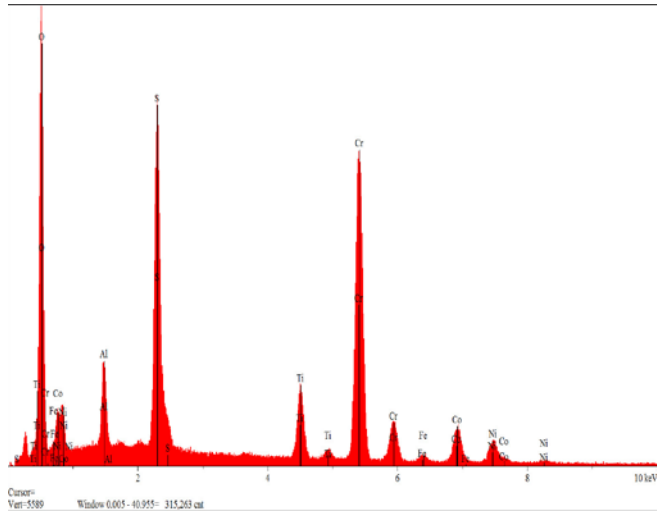
Figure 24. EDS analysis indicating the presence of Chromium Oxide and Chromium Sulfide

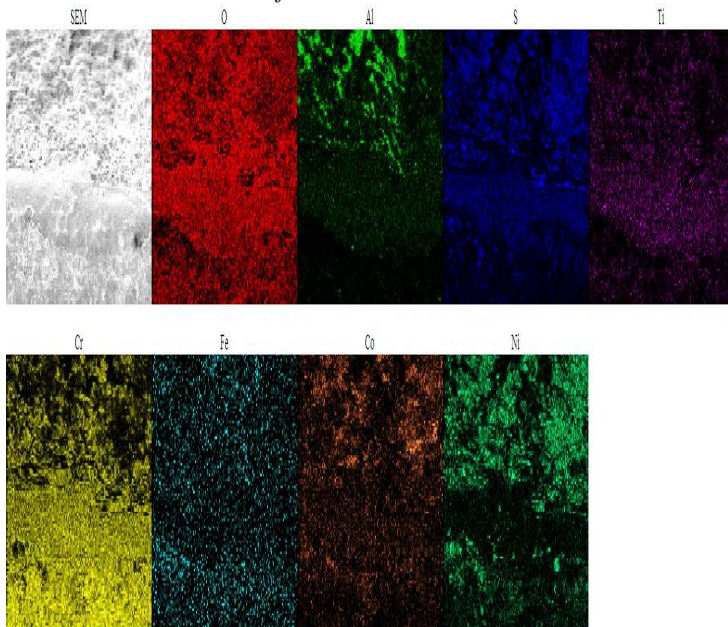
Figure 25. X-ray mapping of area in Figure 23 showing the concentration of the elements. Note the lack of Nickel (Green) in at this area.

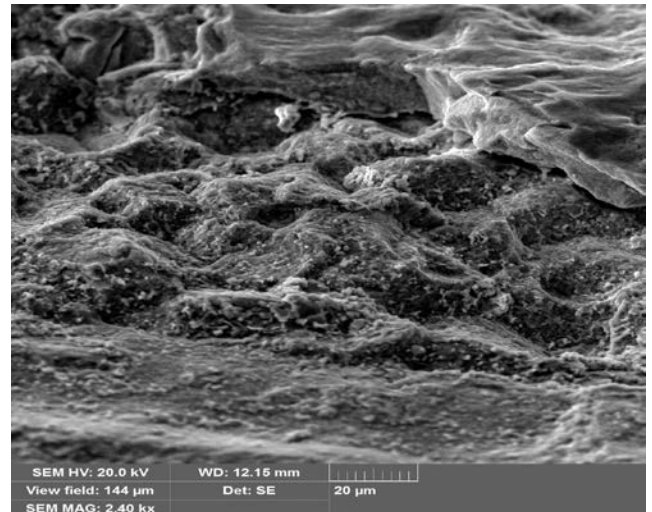
After stripping using acetate tape some small intergranular areas could be seen near the initiation point (Figure 26). Further away from the point of initiation in which the surface is less obscured the crack propagation had an intergranular appearance (Figure 27). The crack propagated in an intergranular manner through most of the blade until final overload which showed dimple rupture (Figure 28). Final overload occurred near the discharge side on the non-pressure side of the blade.

Figure 26. Stripping the surface with acetate tape revealed intergranular features

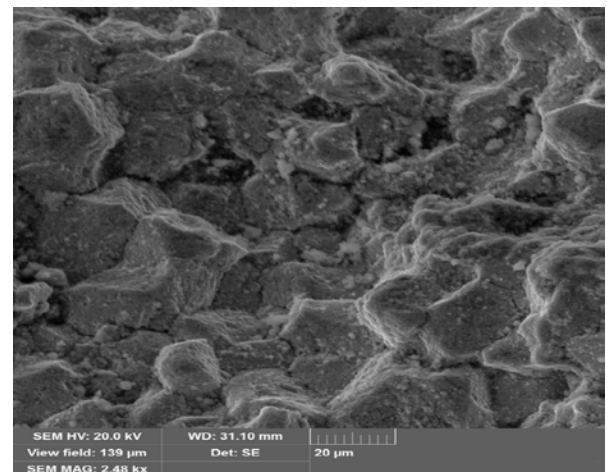
Figure 27. Crack propagation into the blade was intergranular

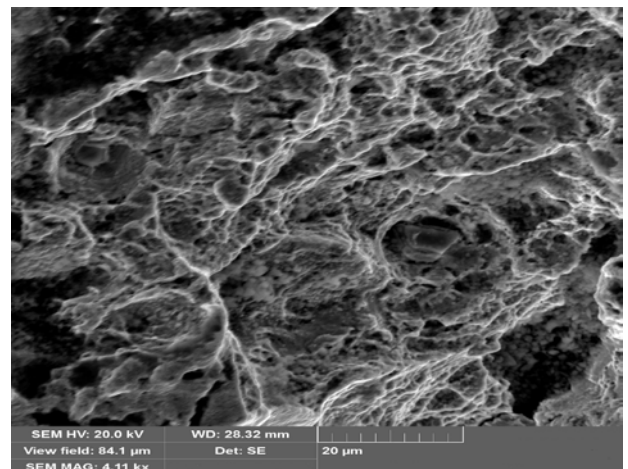
Figure 28. Area of ductile overload and final fracture

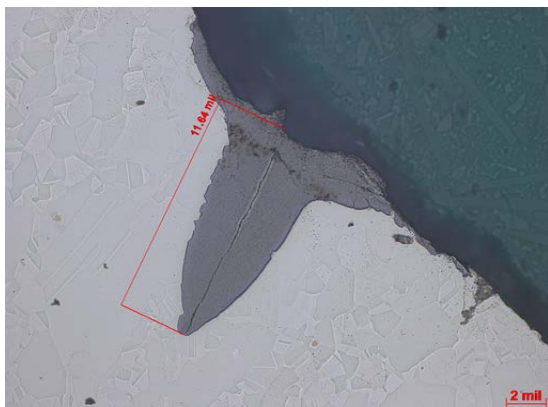
The cross-sections of blades approximately 1.25 inches from the discharge side showed evidence of oxide wedges. An oxide wedge can clearly be seen at the top root radius on the pressure side of the blade (Figure 30). High magnification of the oxide wedge revealed its length to be 11.64 mils. X-Ray mapping of the oxide wedge indicated the presence of the same elements as seen on the flat and smooth areas at the initiation of the failed blade. The oxide wedge mainly consisted of Chromium, Oxygen and Sulfur which suggest Chromium Oxide and Chromium Sulfide. In the center of the wedge was a vein rich in Nickel and Sulfur (Figure 31). Figures 32 & 33 show oxide wedges on other blades approximately 1.25 inches from the discharge side. The largest oxide wedge of 16.84 mils was found in a blade which was two blades away from the one that failed. A SEM micrograph of a cross-section of another blade revealed two oxide wedges in their infancy (Figure 34). Figure 34 illustrates how as the oxide cracks it exposes the base metal to the corrosive environment promoting deeper growth of the oxide wedges.

Figure 30. Cross-section indicating an oxide wedge

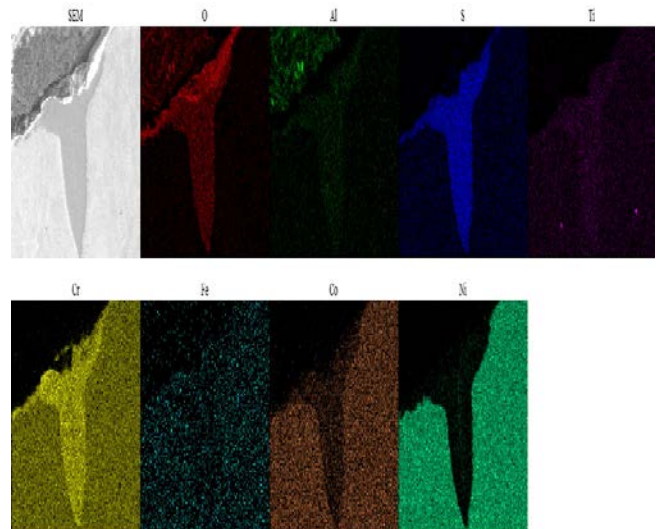
Figure 31. X-ray mapping of the oxide wedge

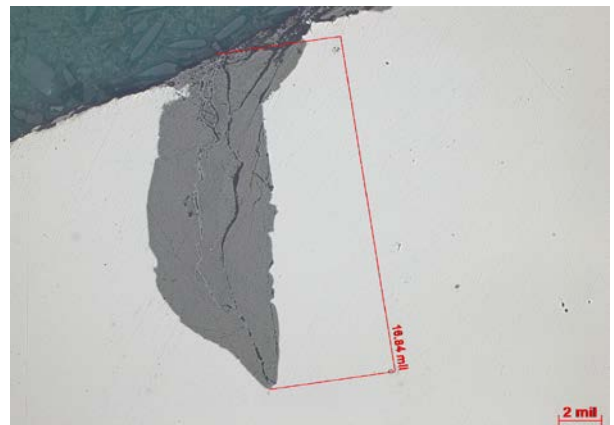
Figure 32. Oxide wedge found on a non-failed blade at 1.25" from the discharge side of the root

Cross-sections of the top fir-tree radius of several intact blades showed evidence of oxide wedges. The size and depth of the oxide wedges varied along the blade with the largest being located approximately 1.25 inches from the discharge side. The point of initiation of the failed blade is approximately 1.25 inches. Oxide wedges form due to repeated crack nucleation and growth of the oxide layer at the oxide wedge tip. The rupture of the oxide at the wedge tip exposes the base metal to the corrosive environment which promotes further growth. These oxide wedges would have given rise to a significant stress concentration. It is this stress riser that initiates the crack and it is the continuing diffusion of the Sulfur into the base metal that propagates the crack under a corrosion fatigue mechanism.

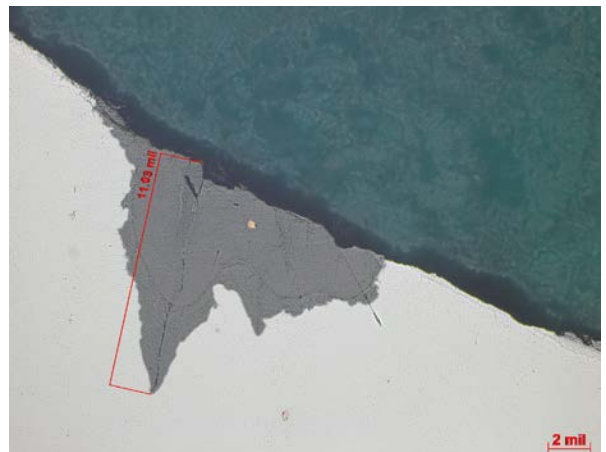
Figure 33. Oxide wedge found on non-failed blade at 1.25" from the discharge side of the root

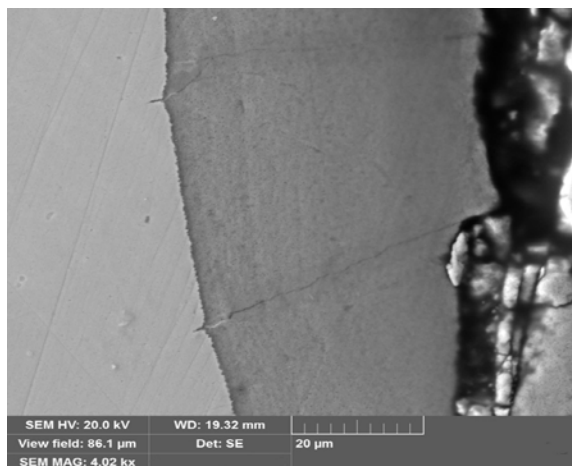
Figure 34. Early stage of oxide wedges

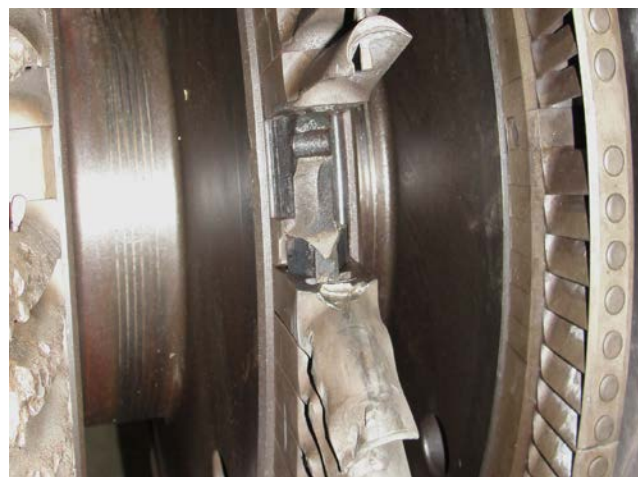
The subject steam turbine experienced a 4th stage disk rim failure near the locking pin location (Figure 35). The subject steam turbine was made from Chromium-Nickel-Molybdenum-Vanadium alloy steel, ASTM A470 Grade C Class 7. The rim was parted from the main body of the disk and sent for metallurgical analysis.

Figure 35. As received condition of the 4th stage failure

The failure mechanism of the subject disk rim was SCC. The chemistry of the disk rim complied with ASTM A470 Grade C Class 7 material requirements. However, there was a significant difference in microstructure and hardness between the areas of the rim with SCC and the areas without SCC. SCC only occurred in the areas with the high hardness. The cause of the SCC failure was due to a combination of high hardness material and corrosive chemical contaminants. The high hardness in the locking pin area of the disk rim would have made the material more susceptible to SCC.

It is unlikely the disk rim would have failed without the high hardness of the material and therefore a weld repair of the disk rim is recommended. The hardness value of the weld

repaired disk rim after post weld heat treatment will be significantly less than 42 HRC. Therefore, the risk of failure by SCC will be significantly reduced. It is also recommended, if possible, that an effort be made to reduce the chemical contaminants in the steam. While not the sole cause of failure, the contaminants were a contributing factor.

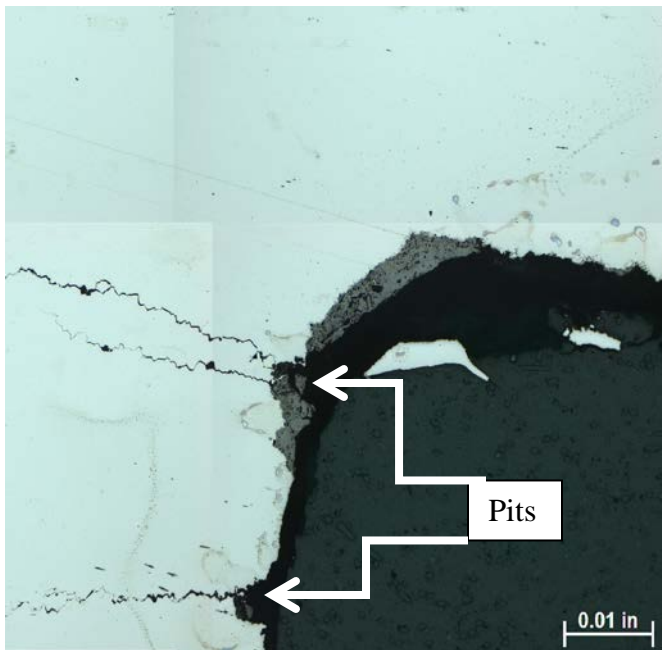
Visual examination revealed additional cracking on the disk rim other than the main fracture. The additional cracks were cross-sectioned and polished. Evidence of cracking was observed initiating from three of the four fir-tree root radii. Examination under a high powered microscope indicated the cracks were intergranular and initiated from corrosion pits (Figure 36).

Figure 36. Corrosion pits from which the SCC initiated

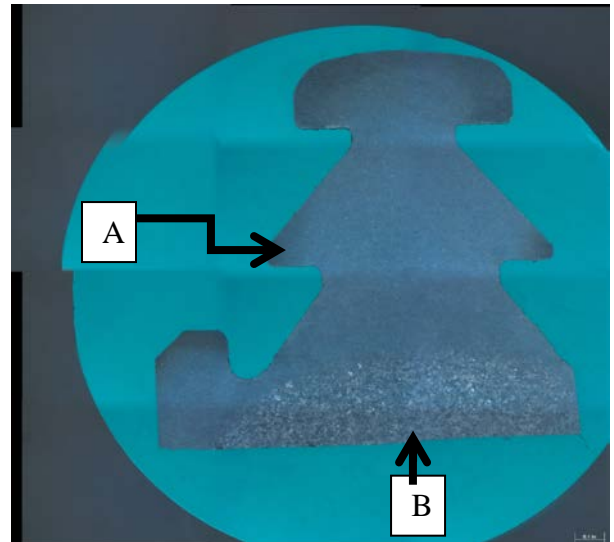
Microstructure examination of the cracked disk rim area presented evidence of two different microstructures (Figure 37). Area A consisted of a fine grained untempered martensitic structure with a hardness of 42 HRC (Figure 38). This value of 42 HRC represents a significant increase in hardness compared to ASTM A470 Grade C Class 7 rotor forging specifications. Area B consists of tempered martensite and bainitic microstructure with a hardness of 26 HRC (Figure 39). Area B is more typical of an ASTM A470 Grade C Class 7 rotor forging. A cross-section of the disk rim with no evidence of cracking is shown in Figure 40. The entire cross-section exhibited a tempered martensite and bainitic microstructure with a hardness of 26 HRC (Figure 41).

Figure 37. Two different microstructures after etching

The most likely cause of the high hardness is the application of high temperature to this area. If the material was heated to a temperature over its A_{c1} temperature then it would harden upon cooling. A_{c1} is the temperature in which austenite begins to form upon heating which depending on the cooling rate can form hard phases such as untempered martensite. If not followed by a tempering heat treatment then this hardness would remain high. How and when this area experienced this high temperature is unknown. However, the localized area of the high hardness and the fact the blades obscure the disk rim suggests it is unlikely the high hardness is the result of a rub during service.

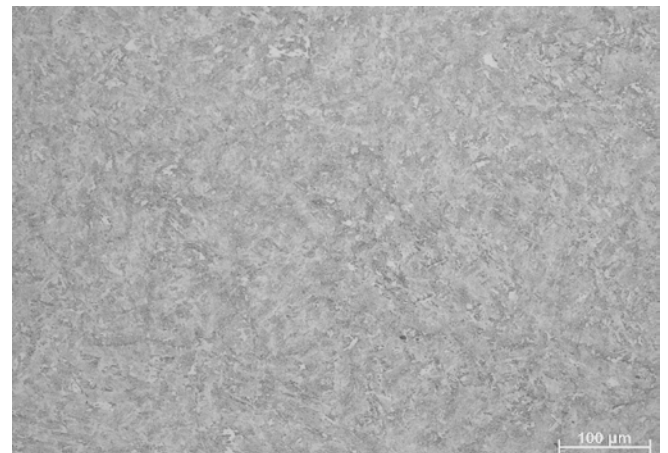
Figure 38. Fine grained untempered microstructure of area A

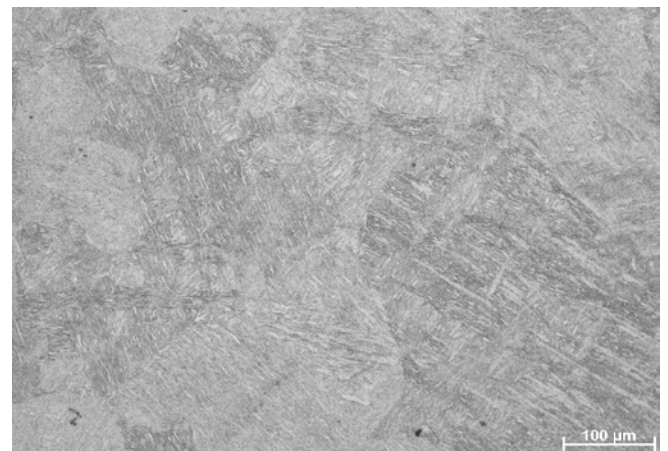
Figure 39. Tempered martensitic and bainitic microstructure of area B

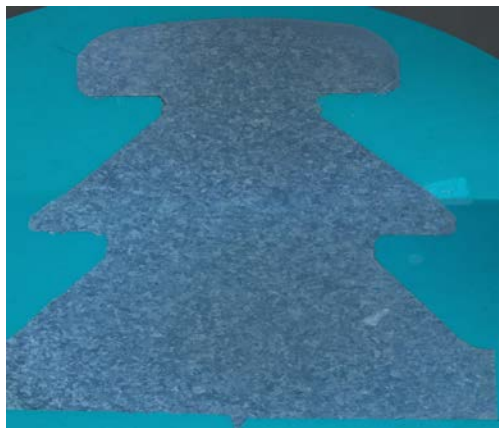
Figure 40. Cross-section near the fracture with no cracks

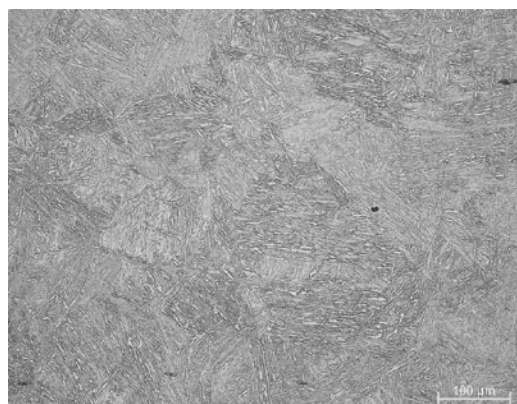
Figure 41. Cross-section in Figure 40 consists of a martensitic and bainitic microstructure

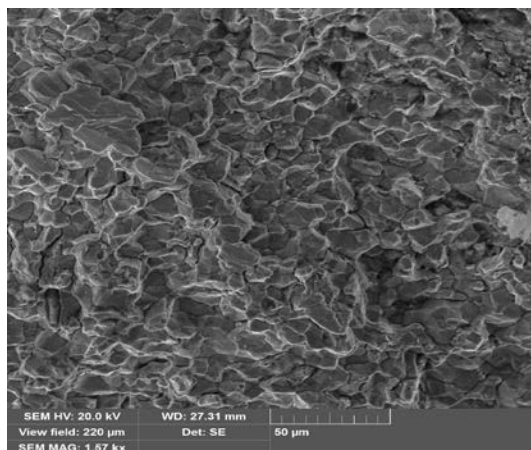
The fracture surface was examined in detail using a scanning electron microscope (SEM). All locations exhibited the same intergranular fracture surface features which is typical of SCC on steam turbine rotor material (Figures 42).

Figure 42. SEM micrograph showing typical intergranular features of SCC

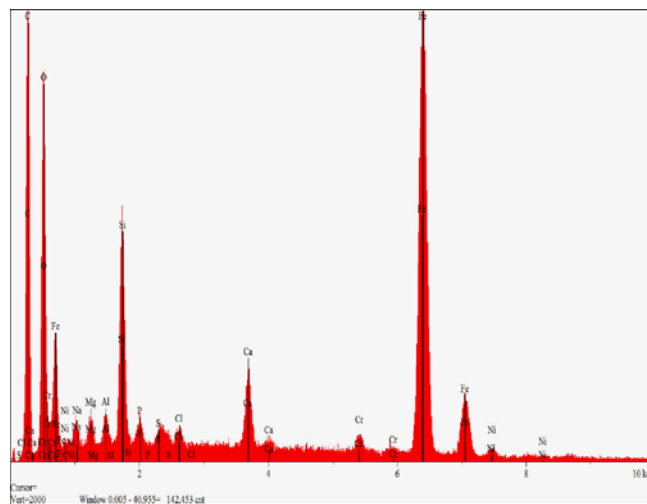
Energy dispersion spectroscopy (EDS) of the corrosion pits revealed evidence of chemical contaminants. Elements such as K, S, Cl and Na were found and are well known to cause SCC (Figure 43). EDS and chemical analysis indicated the disk rim material was from an ASTM A470 Grade C Class 7 rotor forging.

Figure 43. EDS analysis of corrosion pit indicating the presence of chemical contaminants.

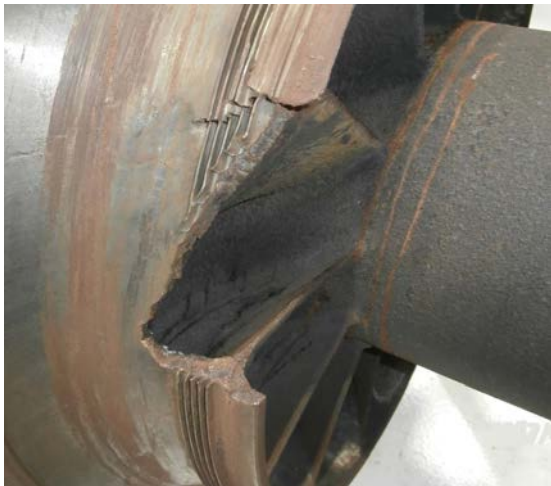
The subject three stage compressor was shut down due to high vibration. During disassembly of the compressor it was observed that a section of the first stage impeller cover at the eye seal area was missing (Figure 44). A heavy deposit was observed in the gas path of all three impellers (Figure 45). The deposits were removed from all three impellers and bagged for future analysis.

Figure 44. Fractured impeller on the rotor

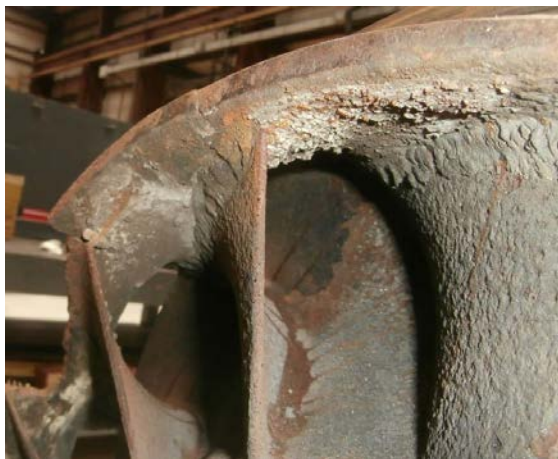
Figure 45. Heavy deposits observed in the gas path

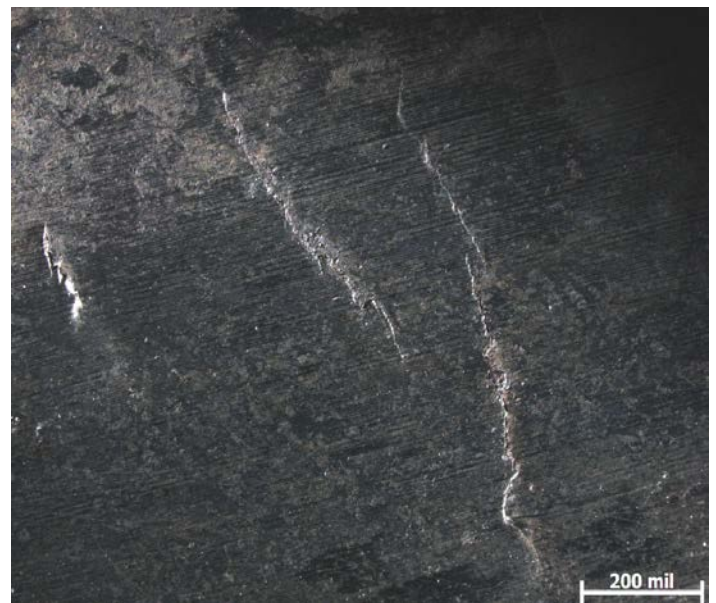
Visual examination revealed additional cracking near the eye seal area of the impeller (Figure 46). Heavy hard deposits were observed at the blade to cover transition radius (Figure 47). The heavy hard deposits appear to coincide with the location of the cracking on the cover.

Figure 46. Additional cracks observed near the eye seal area

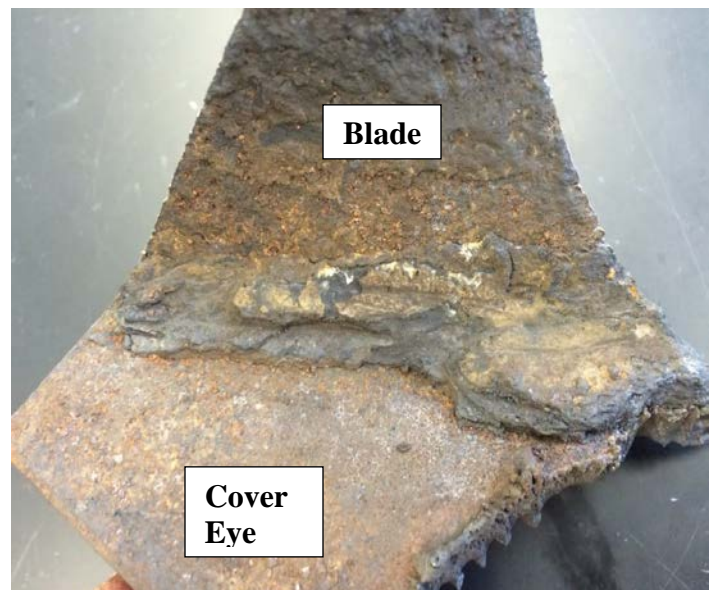
Figure 47. Heavy and hard deposits observed at the blade to cover transition radius

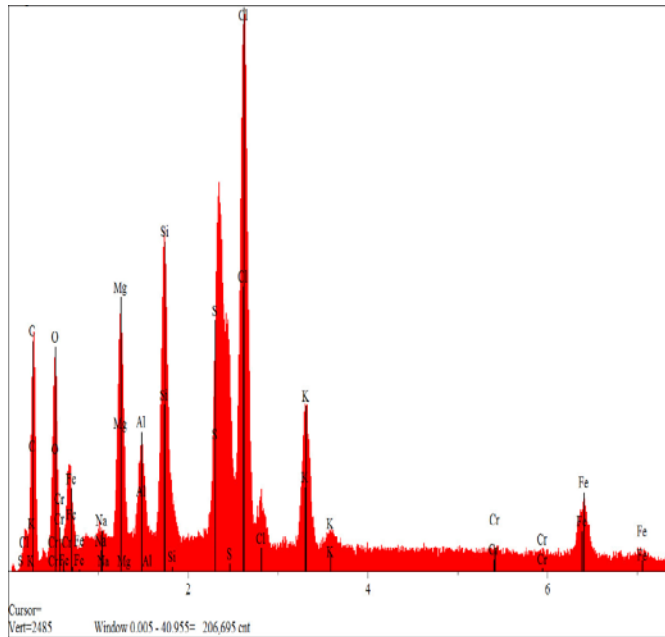
Deposits collected from the first, second and third stages were analyzed in the scanning electron microscope (SEM) to determine its constituent elements. Energy dispersive spectroscopy (EDS) analysis of the deposits revealed the presence of Sodium(Na), Magnesium(Mg), Aluminium(Al), Silicon(Si), Sulfur(S), Chlorine(Cl), and Potassium(K) (Figure 48). Deposits on the fracture surface of the first stage impeller revealed the presence of the same corrosive constituents.

Figure 48. EDS analysis deposit presenting evidence of corrosive contaminants

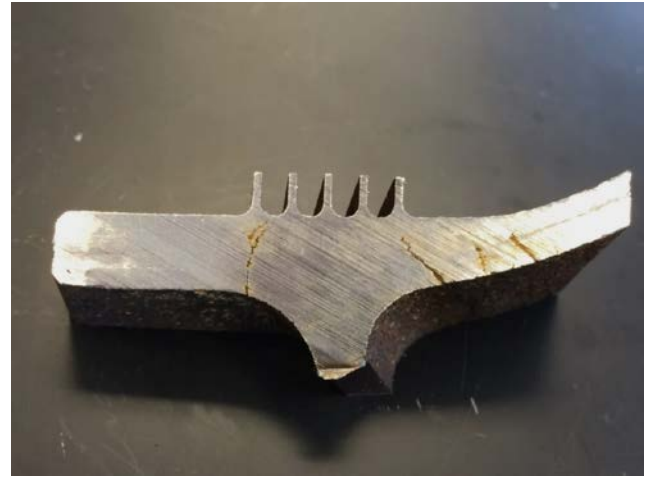
Figure 49. Cross-sections showing cracks initiate inside the gas path and propagate towards the outside surface

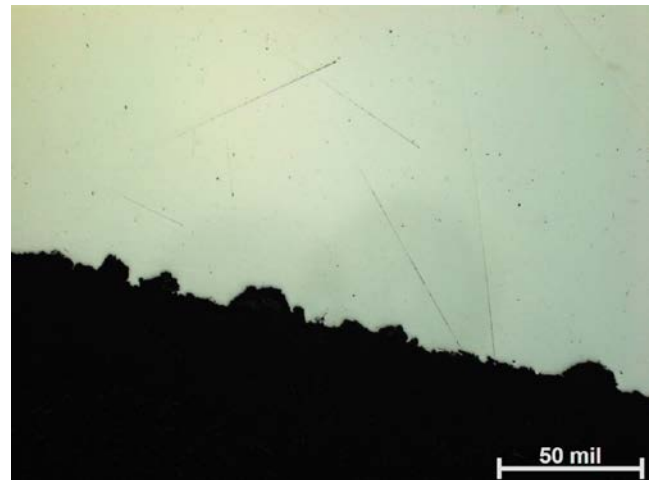
Figure 50. Multiple pits observed inside the gas path of the cover

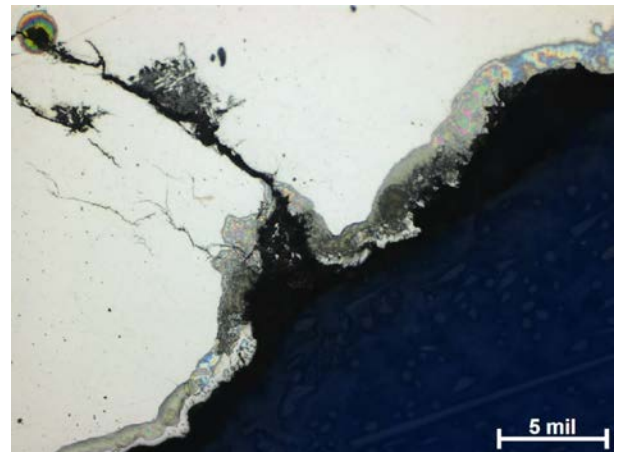
Figure 51. Initiation of the cracks occurred at corrosion pits

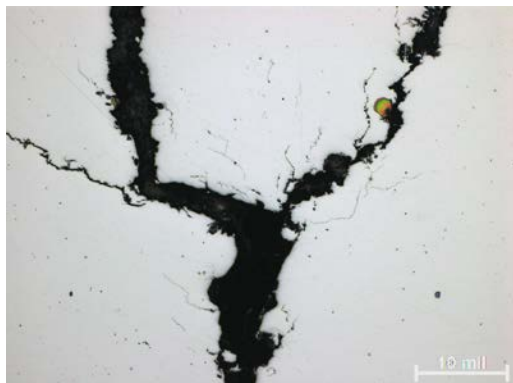
Figure 52. Significant branching was observed which is a indication of corrosive attack

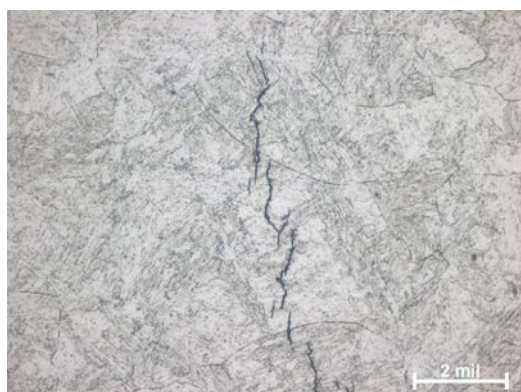
Figure 53. Transgranular morphology during crack propagation

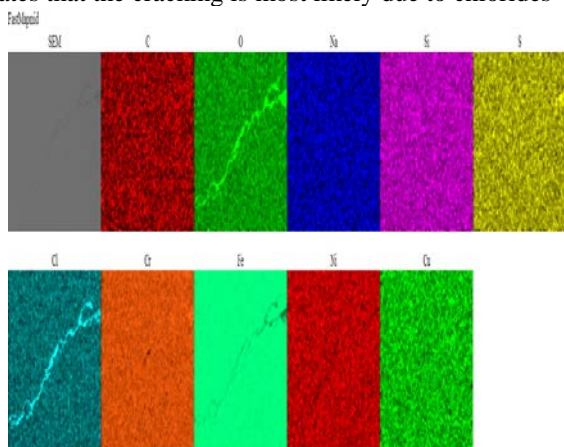
Figure 54. Smaller tighter cracks indicated the presence of chlorides(Cl) (Light Blue)
